# Service Bulletin

## Dual Frauscher Bracket Failure Investigation

Document 480063

Application: This service bulletin covers the mounting bracket (Comet PN#:400229 provided for application of the Frauscher zero speed wheel sensors to the Progress Rail Micro HBD.

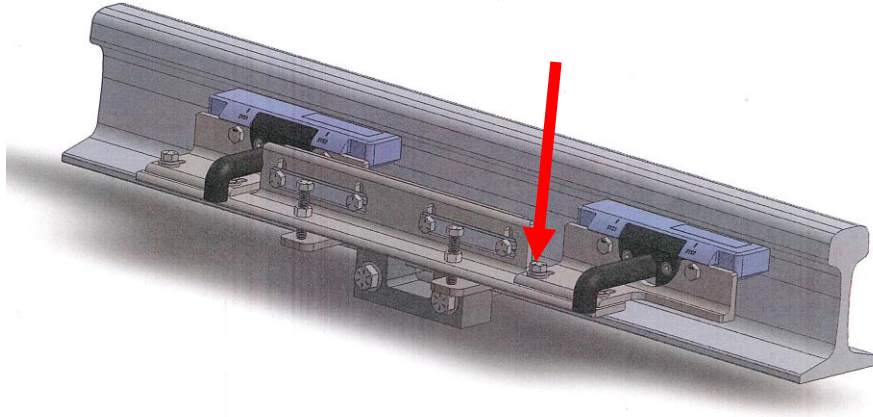
**Type:** The bracket is failing in a classic fatigue pattern, which should allow for detection prior to complete failure. The timeframe from detection to failure is unknown.

**Location:** Failures are reported as occurring on the right side of the main bracket, at the root of the fillet where the angle has been removed and the wheel sensor extends beyond the bracket (as shown in the diagram directly below).

**Factors:** Factors that lead to failure are unknown. Suspected causes include elements that create a stronger or more consistent vibration, such as:

- Track pumping.
- Bolted track joints nearby.
- Tie or spike problems in the vicinity.
- Heavy traffic.

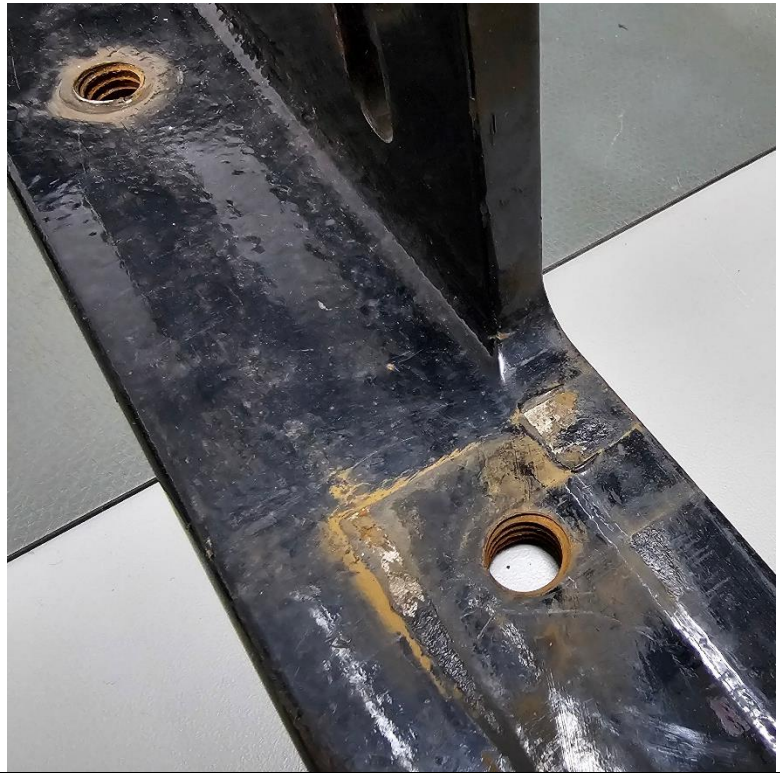
**No Failure:** There is no evidence of fatigue in the root of the transition.

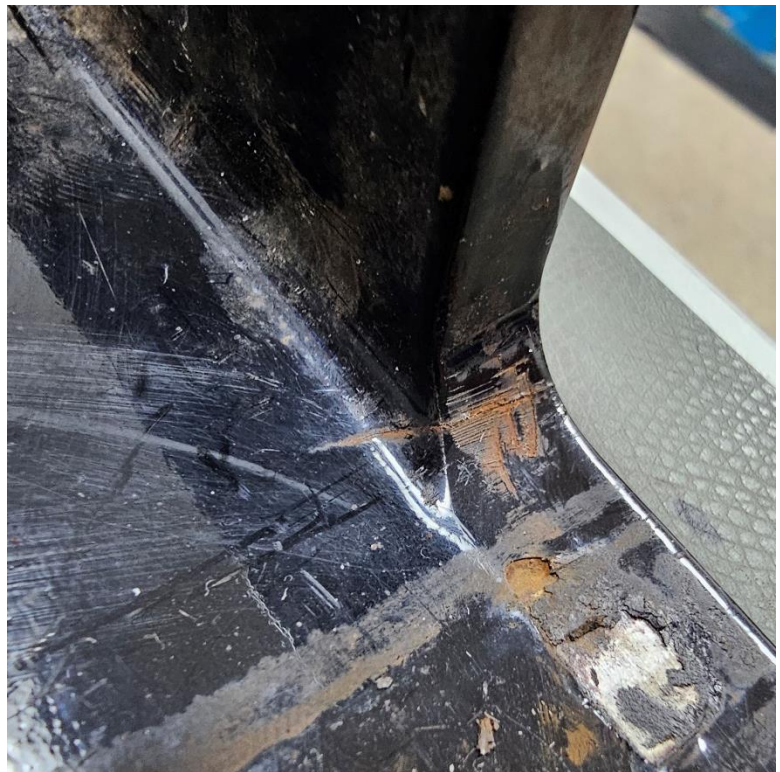
**Stage 1:** Crack forming across the face of the fillet. Crack has not propagated into the flat of the piece.

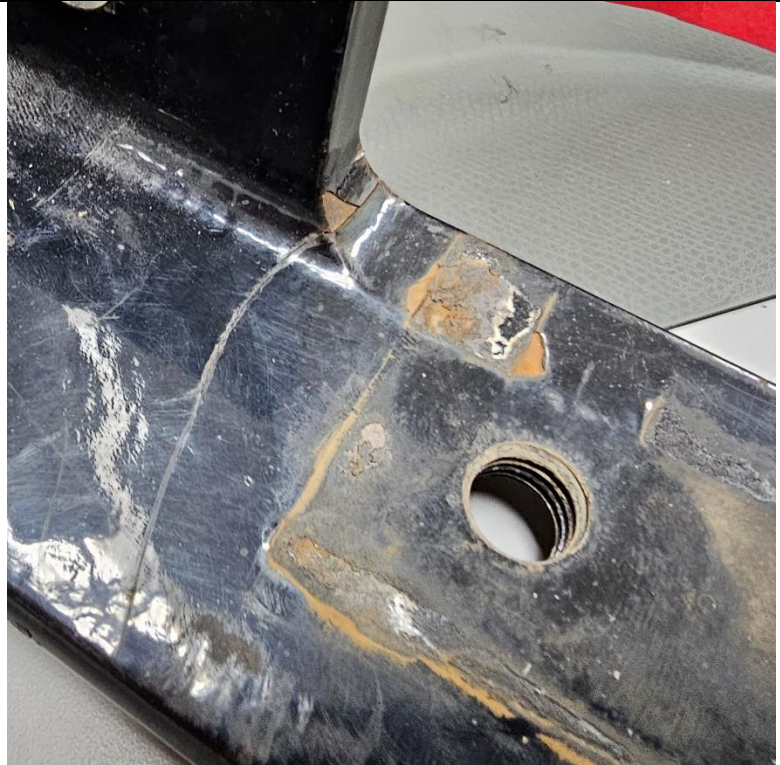
**Stage 2:** The crack is propagated across the face of the horizontal bar.

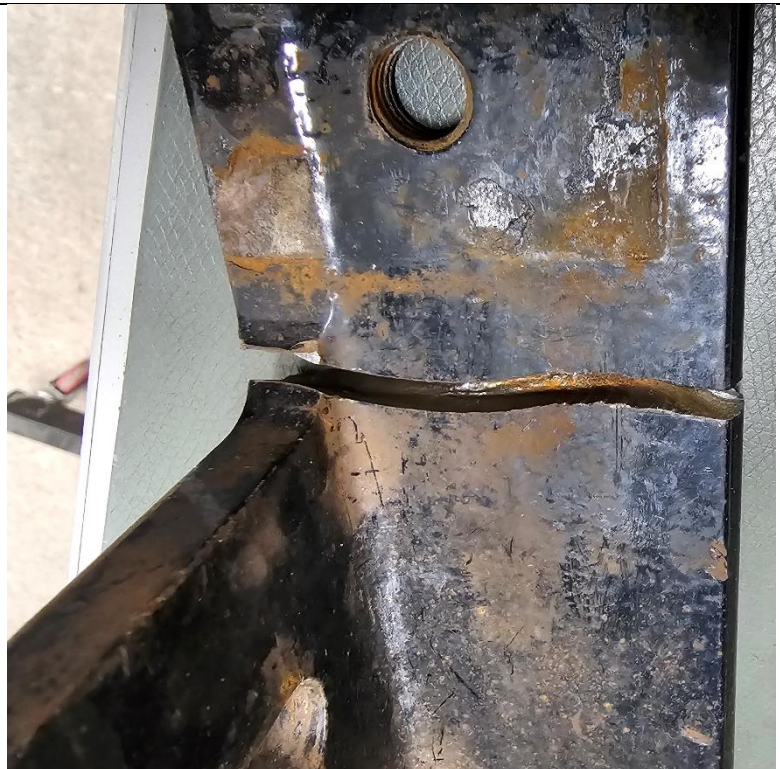
**Stage 3:** Complete failure. The bar has cracked into two pieces.

To mitigate field impact, for the duration of this action (90 days) following the release of this bulletin, Comet will provide a replacement bracket free of charge for any site that can document any stage of failure.
